BORE POLISHING IN A RUNNING DIESEL ENGINE

A thesis submitted for the degree of

SEPTEMBER 1982

Lubrication Laboratory  
Department of Mechanical Engineering  
Imperial College of Science and Technology  
London SW7 2AZ

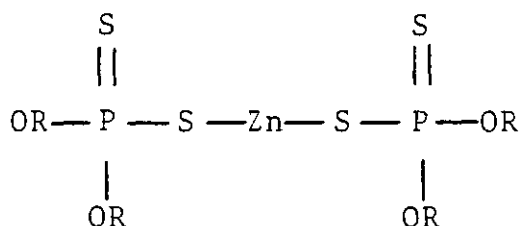
FIG 1.1 GENERAL FORM OF A ZDDP

This thesis is concerned with crankcase lubricants. These generally contain one antiwear additive, zinc dialkyl-dithiophosphate. This has the general form shown below.

Although generally speaking an antiwear additive, it can also be quite corrosive, and behave as an E.P. additive. It also doubles, in crankcase lubricants, as an antioxidant.

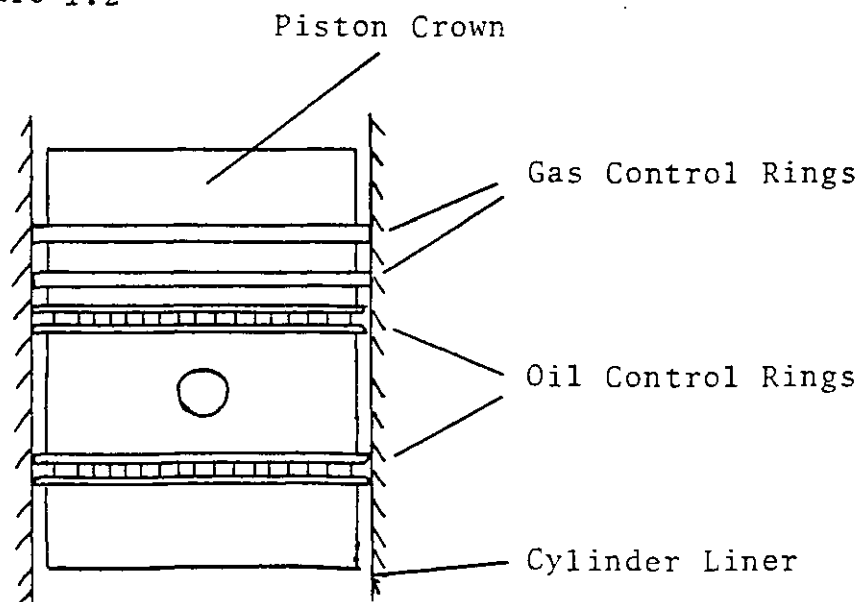
In a diesel engine a piston compresses air and at the top of the stroke (top dead centre - T.D.C.) fuel is injected and ignites forcing the piston down the cylinder. The exhaust gases are sealed by a series of piston rings as shown in Figure 1.2

There are a range of piston rings used in diesel engines. The upper rings deal primarily with gas control with some oil control function, whilst the lower rings have a primary oil control function. In this context it is common to have several types of ring: compression, single taper, oil control, double taper (barrel), oil scraper and so on. The primary functions of the rings are:

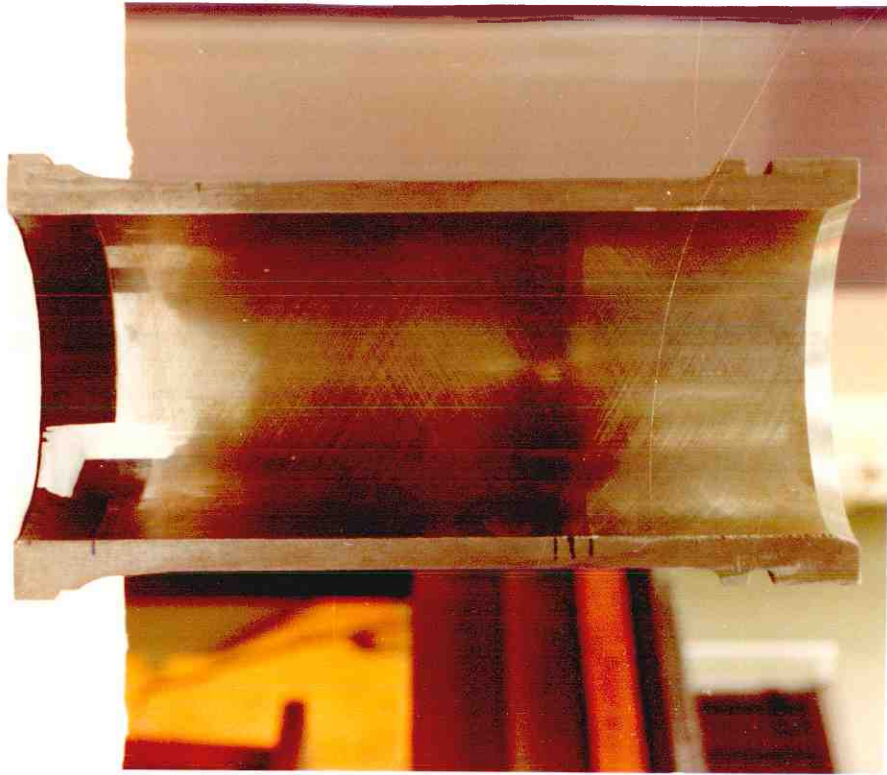
Figure 1.3 Cylinder with Bore Polishing (Petter AVB)

TDC

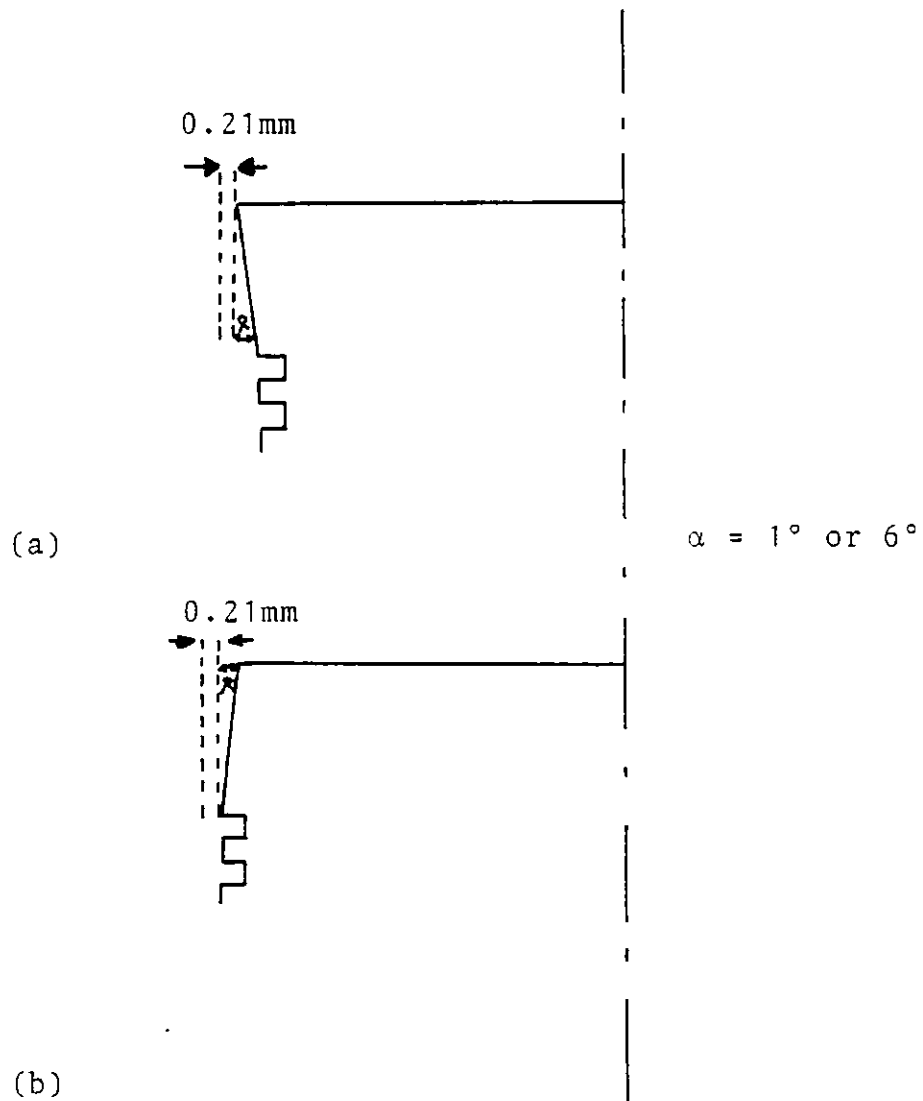
FIGURE 1.5 Two Different Crown Land Profiles

Various methods have been employed to reduce cylinder liner wear and bore polishing. Furuhashi and Hiruma (43) report on a series of tests in which the crown land shape was altered. The crown land shape (a) on page 40 gave very high oil consumption whilst profile (b) gave very low oil consumption. The main observation from these tests was that oil on the cylinder wall in case (a) was scraped up by the piston land edge and burnt by the combustion flame. In case (b) the oil was not scraped up and was not burnt by the combustion flame. Consequently carbon deposits were found with (a) but not with (b). Dinsmore(32) also mentions cutting back the crown land and states that it minimises hard carbon build-up on the crown land. It is clear that the crown land profile is important. The effect of piston misalignment has been investigated by several experimenters, in particular

Furuhamma and Hiruma (43). The piston was slightly offset and an increase in oil consumption noted. This effect was also noticed by Wilson and Calow (33) and considered to effect bore polishing.

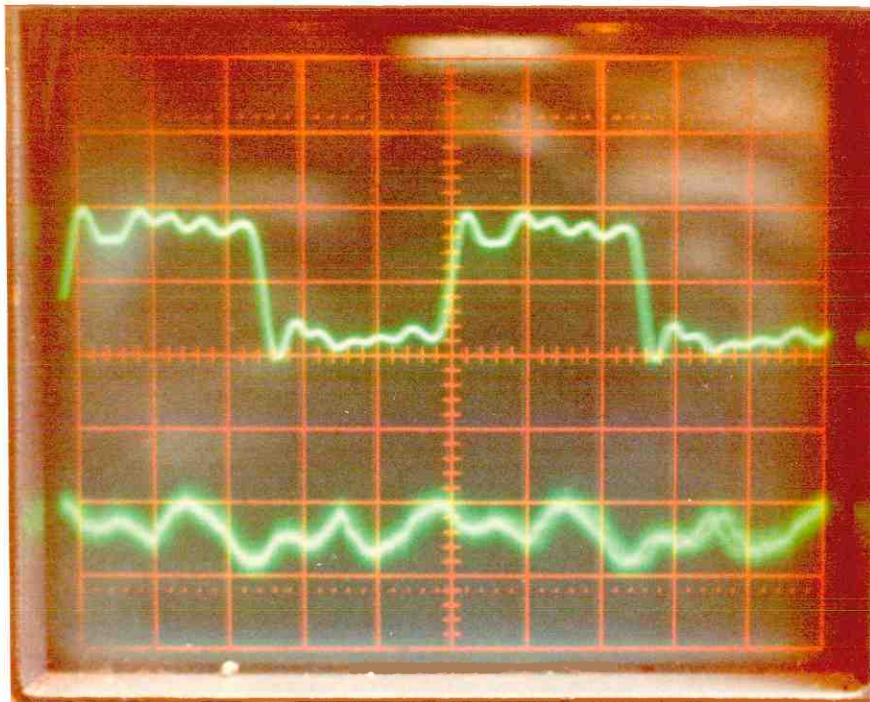
The output from the charge amplifier was monitored throughout each test. The photograph on Page (84) illustrates a typical oscilloscope output. The friction force is the upper trace. The 'jagged' profile is due to slight vibrations of the apparatus, the frequency of which

Figure 3.1 View of Oscilloscope

corresponds to its natural frequency. These vibrations, although negligible, produce an undesirable affect on the oscilloscope output. This is mentioned again in Chapter 7.

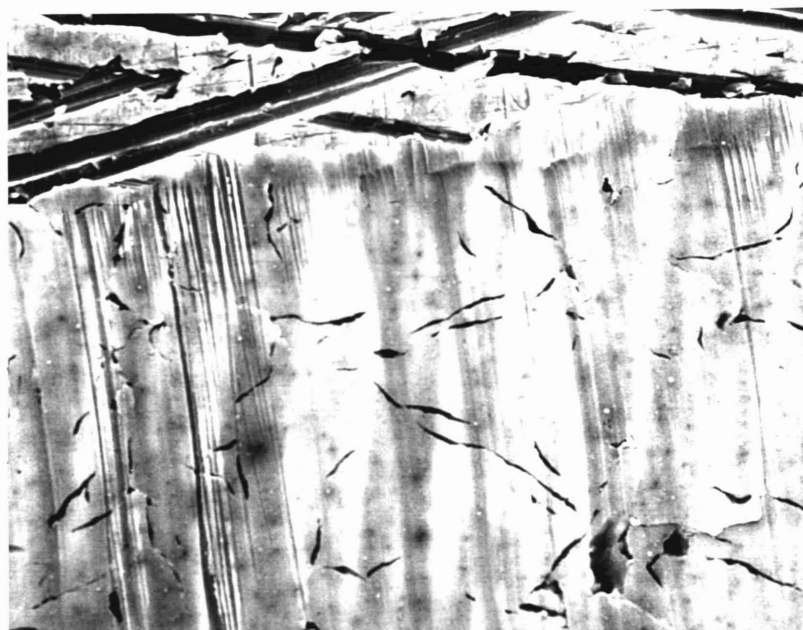
Figure 3.12 S.E.M. View of H.F.R. Test Liner with Polishing (200x)

It was necessary at the outset to determine whether bore polishing, as defined by Wilson and Calow (33) and others, could be obtained using the H.F.R. apparatus. For this purpose the reference oil C2 (45% bore polishing percentage) was tested for a range of temperature and time conditions. Figures ( 3.10-3.12 ) show clearly the similarity between the Ford Tornado liner, the liner taken from a service engine with bore polishing and the liner used in the H.F.R. apparatus. Figures 3.13 and 3.14 are included for reference.

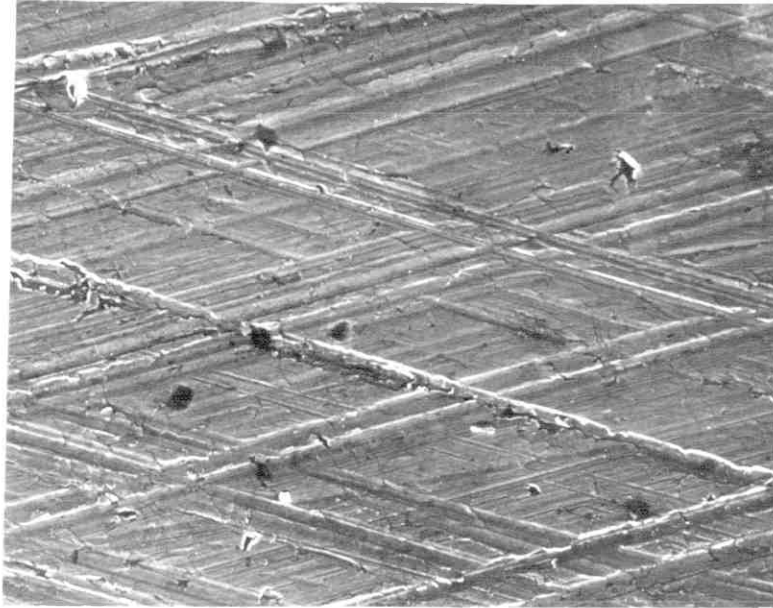
Figure 3.13 S.E.M. View of Untested H.F.R. Liner (200x).

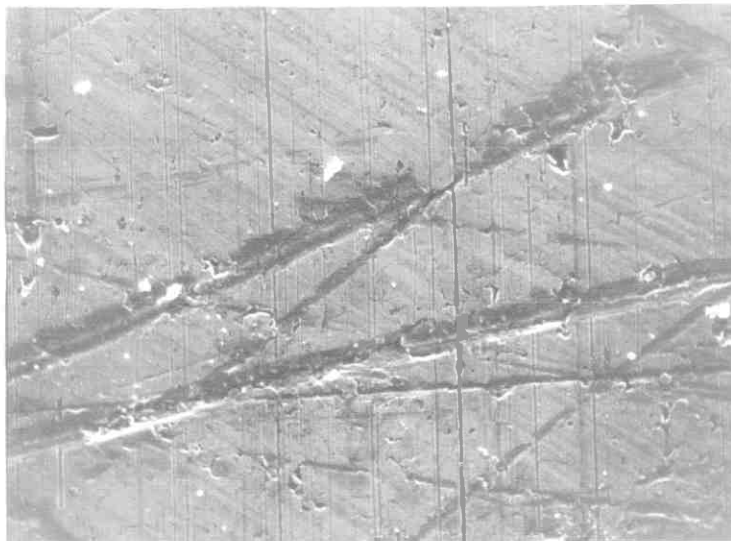
The photographs on Page 104 are representative of the six tests conducted in which the liner surface of C1 is much rougher than that of C2 as evidenced by the removal of the original honing pattern in C2. These tests show clearly that the H.F.R. apparatus can distinguish between two oils of known bore polishing percentage. Photograph 3.15 shows honing lines visibly whilst photograph 3.16 shows polishing.

Figure 3.15 S.E.M. View of Liner with C1 at 200°C (500x)

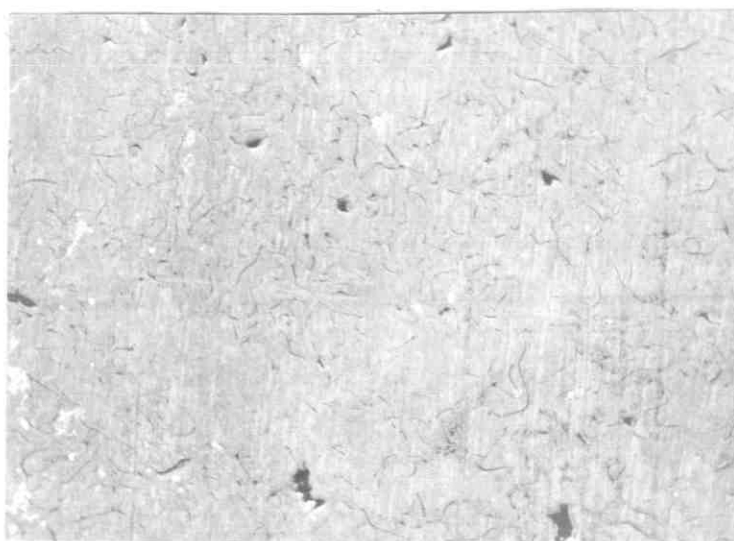
Figure 3.16 S.E.M. View of Liner with C2 at 200°C (500x)

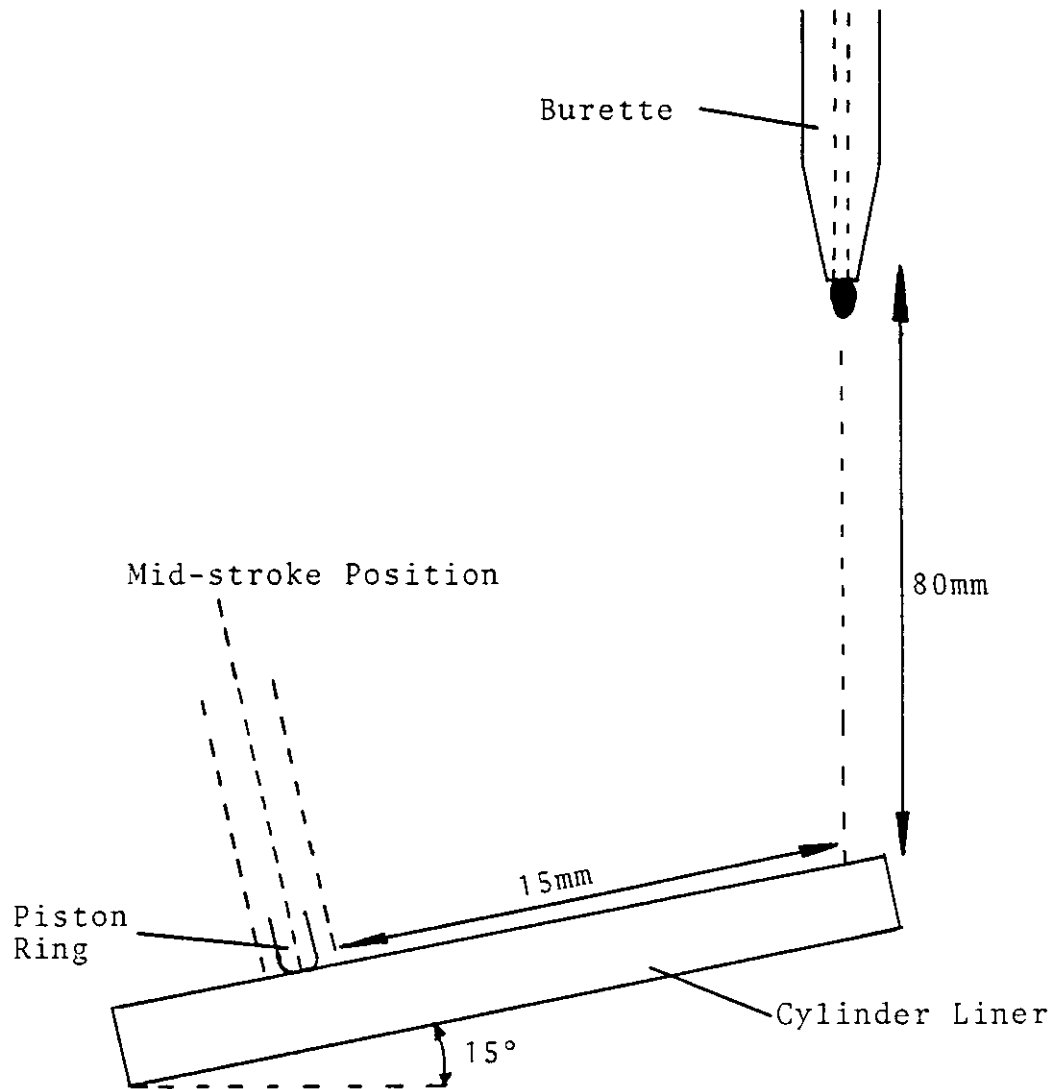
FIGURE 4.1 Drip Feed System (not to scale)

It was found that if the burette was placed within 50 mm of the hot liner surface the oil feed rate was not constant. This occurred because the oil at the base of the burette became heated and its viscosity was not constant. To eliminate this problem the burette was placed

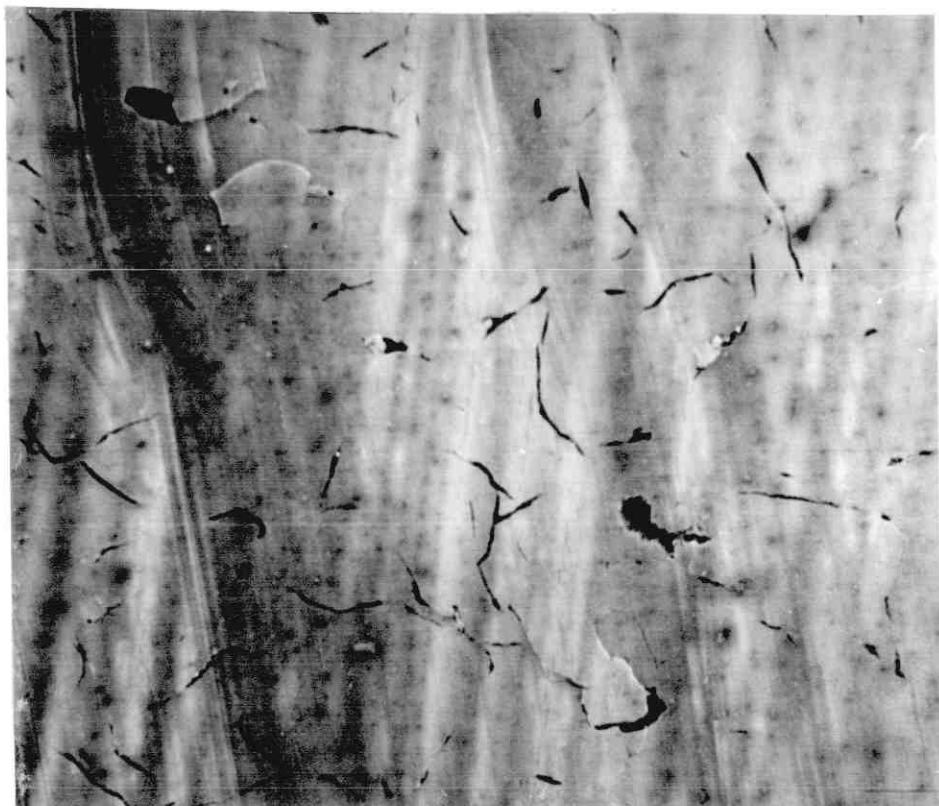
C2 (Figure 4.8) and C4 (Figure 4.9) produced a smoother surface than the other oils, e.g. Figure 4.10. This is evidenced by the removal of the honing pattern. Engine tests also identified C2 (45%) and C4 (55%) as giving heavy bore polishing, although the test conditions are not identical. In particular there were no combustion products in the H.F.R. tests. It is clear from this observation that the lubricant has a more important role in the phenomenon of bore polishing than previously considered.

Figure 4.9 S.E.M. View of Liner with C4 at 250°C (immersed)  
(200x)

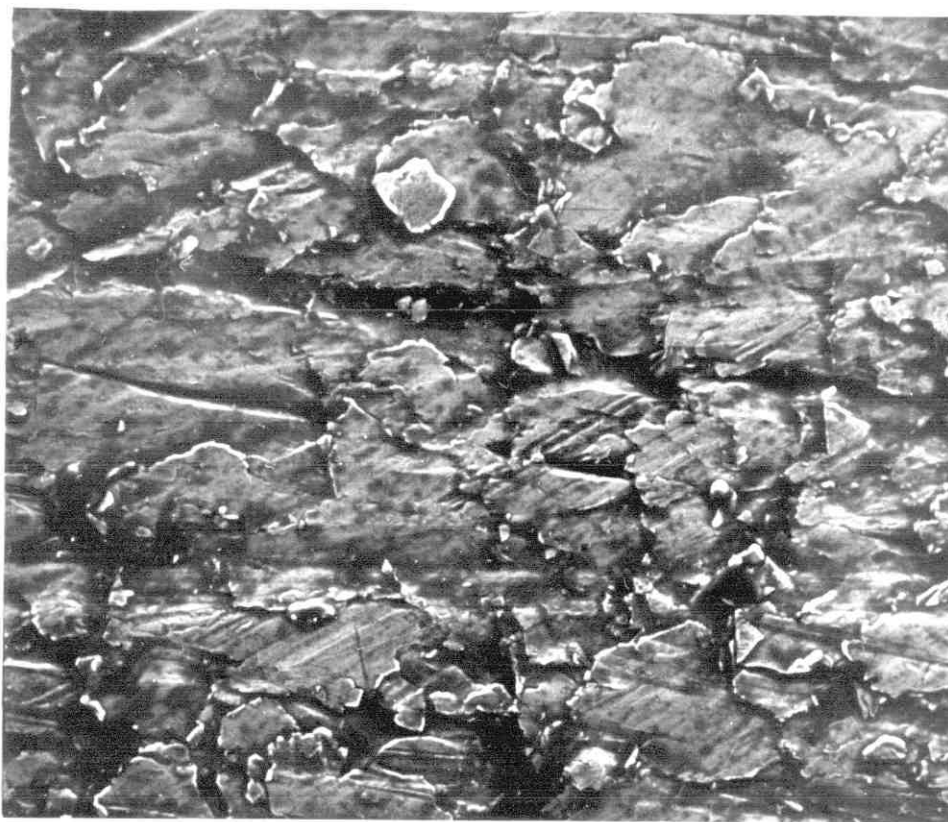
- 2) Higher temperatures appear to promote greater polishing. This is seen by a comparison of Figure 4.11 with Fig 4.12. There is some evidence to suggest possible corrosive pitting on the left hand side of Figure 4.11.
- 3) Evidence of plastic deformation was obtained, as seen in Figures 4.10, 4.12. This observation is particularly relevant when the honing pattern is visible, however in cases where the honing pattern is not clearly defined (as in Figure 4.8) it is not obvious whether deformation has occurred. This uncertainty will be investigated in the next section.
- 4) Evidence of delamination wear was found. This is illustrated in Figure 4.13, which is a high magnification view of a plate-like particle just leaving the surface. The existence of these wear particles is further described in Section 4.3.2.5.

Figure 4.12 S.E.M. View of Liner with C5 at 200°C (immersed) (500x)

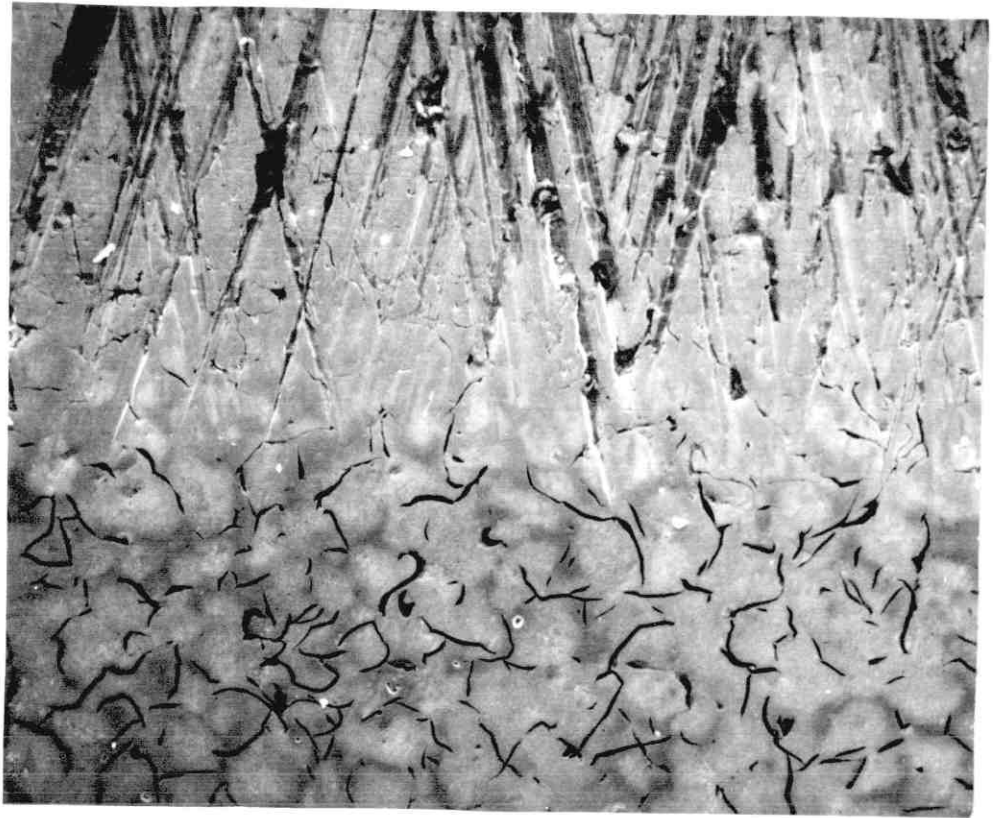
Figure 4.14 Axial Taper Micro-section of Untested Liner.  
(100x)

Figure 4.14 shows an untested liner specimen, which is taper sectioned, allowing a magnification of the subsurface by five times that of the overall photograph magnification. Figure 4.15 shows a taper section of the heavily polished H.F.R. liner shown in Chapter 3 (p101). Both these liners are unetched, as are all the liners shown in this thesis, since it was found that the graphite structure was more clearly defined without etching. A comparison of these two photographs indicates that for the polished H.F.R. liner specimen there is evidence of cracking around the graphite flakes, in some cases forming a semi-continuous crack. This observation will be confirmed by subsequent microstructural studies, these two photographs are included for reference.

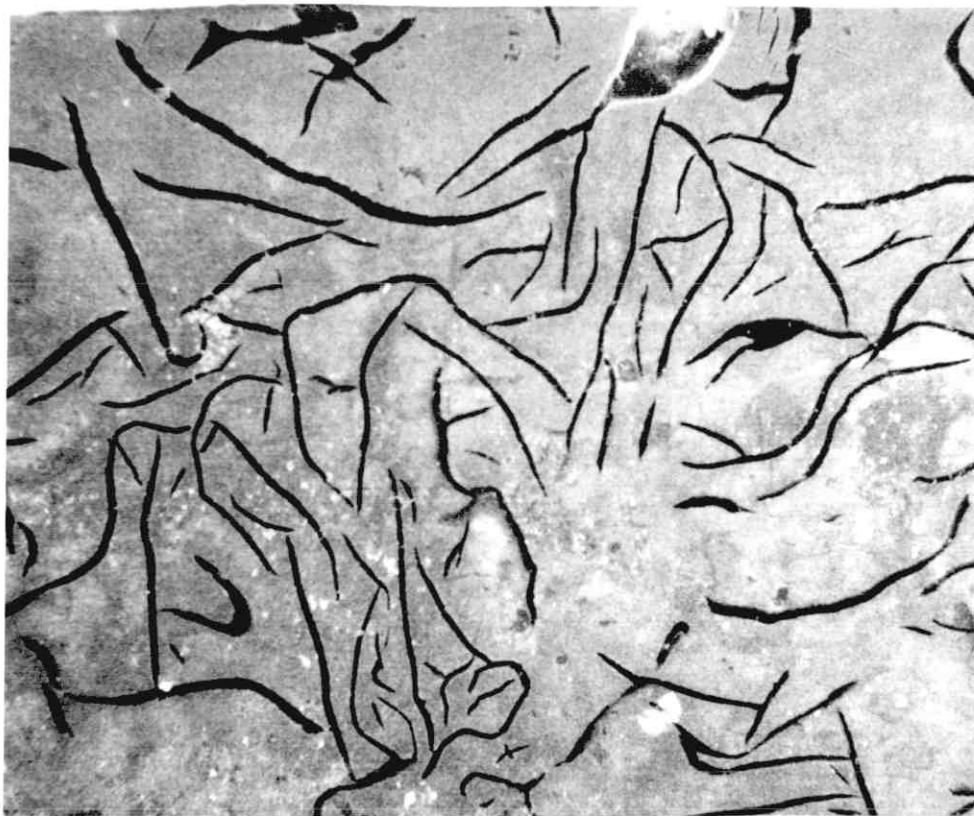
Figures 4.16 and 4.17 are representative of the study of microstructures of H.F.R. liners taken from immersed contact commercial oil tests. Figure 4.16 shows no evidence of cracking whilst figure 4.17 shows extensive cracking around the tips of the graphite flakes, particularly in the top 200 $\mu$ m. These micro-sections are transverse i.e. sliding direction is into the photograph.

Figure 4.16 Transverse Micro-section of Liner with  
C1 at 200°C (immersed). (200x)

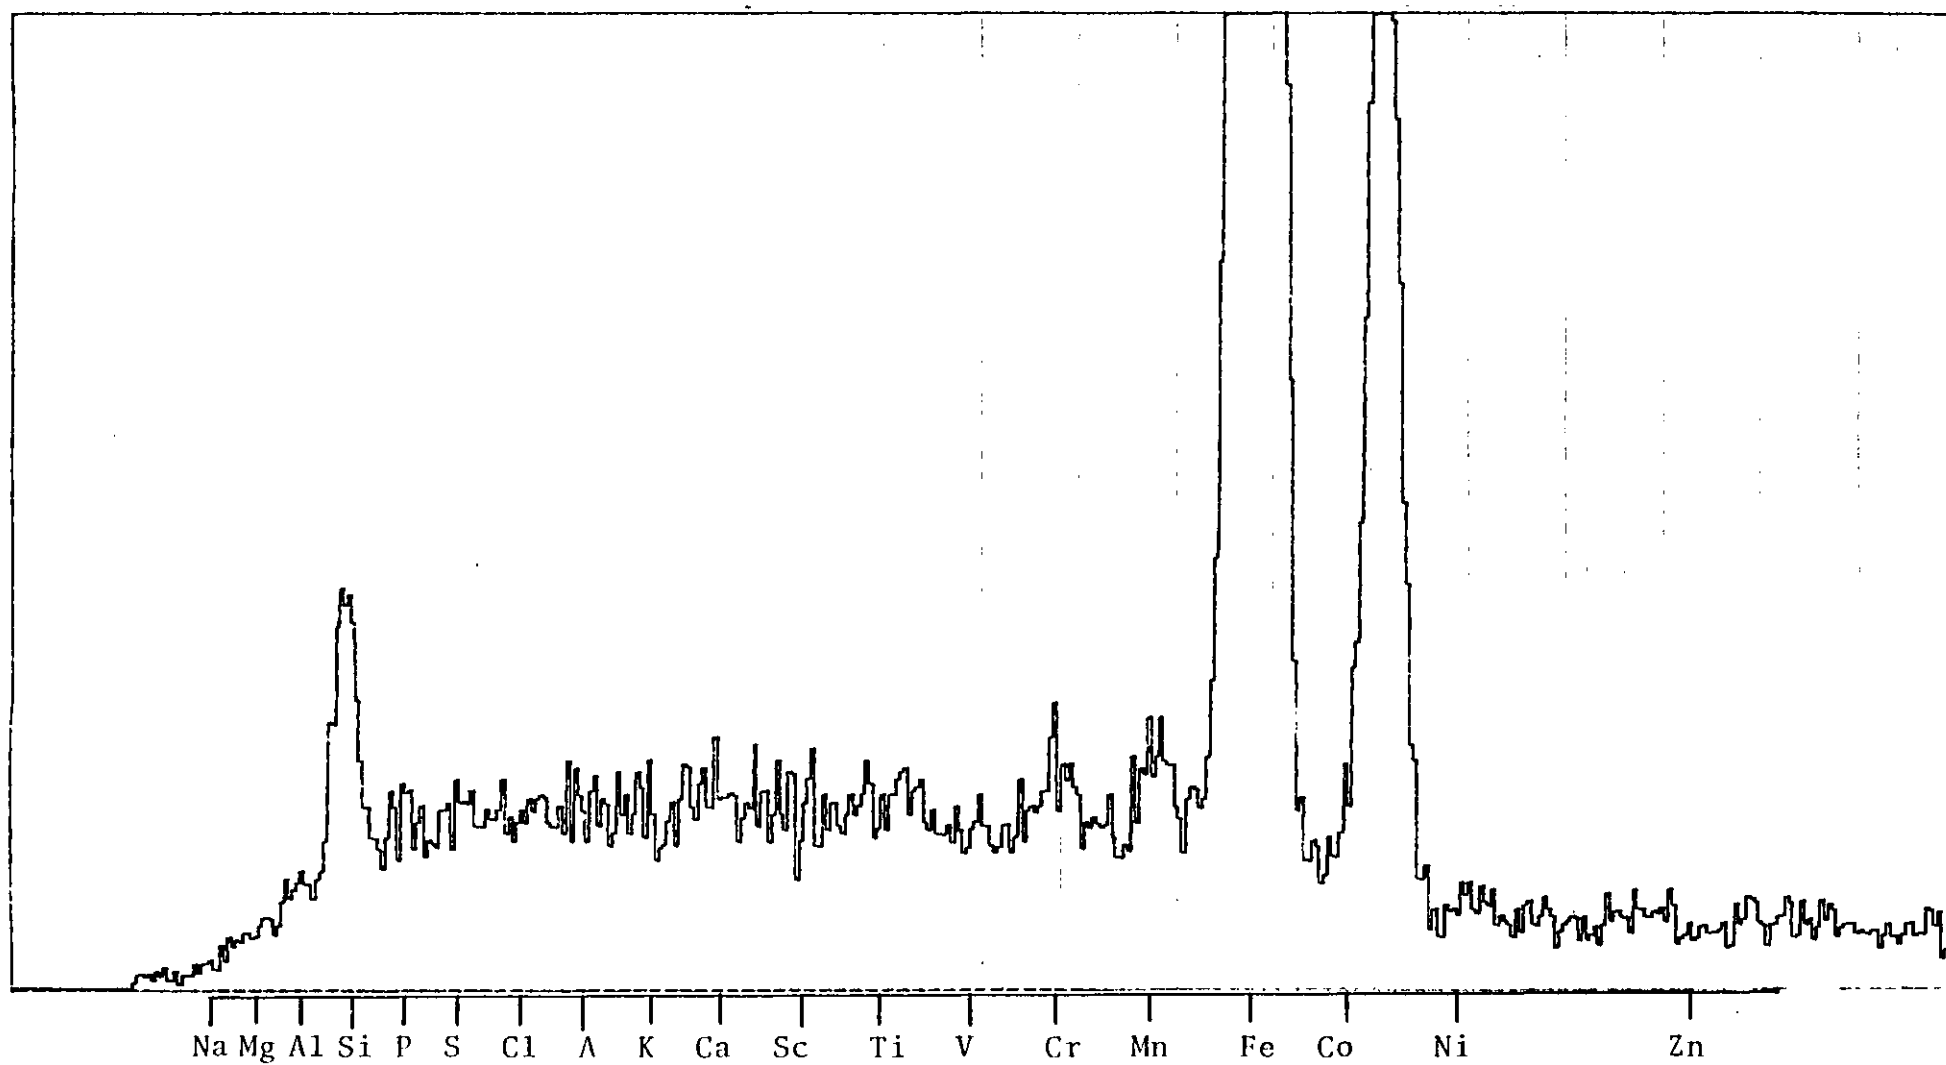
Figure 4.19 M.P.A. of Tested Liner, Not Wear Scar (area)

- 1) Both spot and area analyses of the surfaces of each H.F.R. liner revealed very little variation from the background count shown in figure 4.19.
- 2) A spot analysis of cavities in the wear scar surface did reveal variations, as seen in figure 4.20. In this figure the ratio of sulphur to silicon peak heights is shown for each oil, since this was considered to be more representative than a plot of sulphur peak height for each oil. Figures 4.21, 4.22 are representative of this

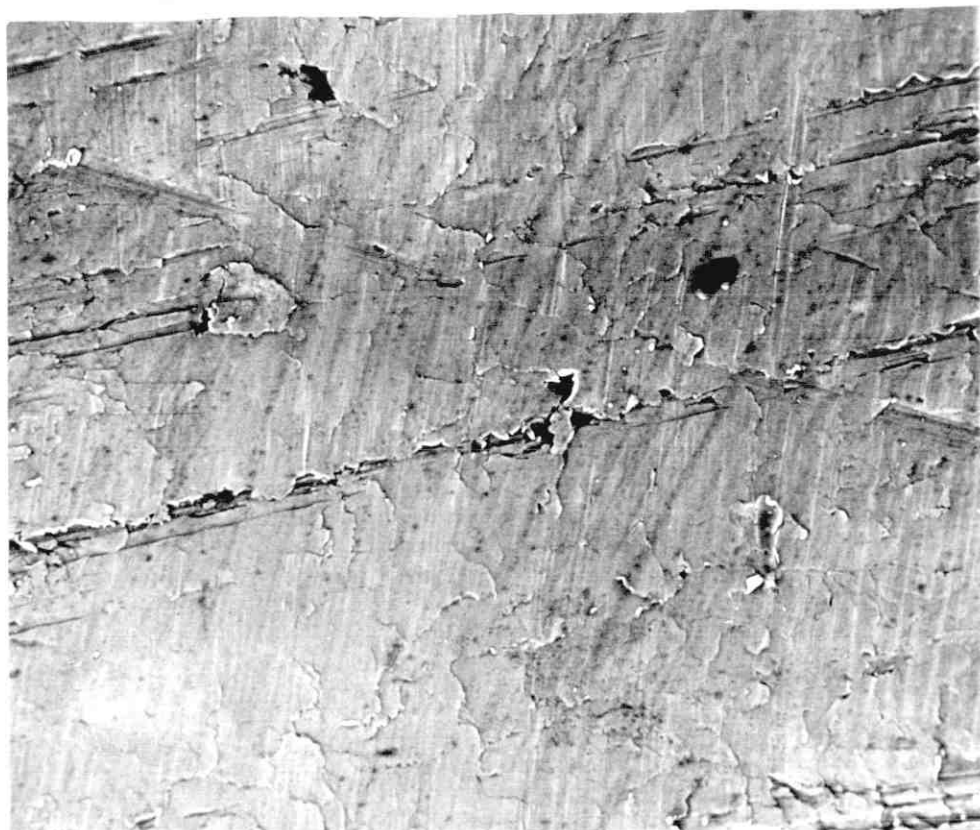
- 1) A good correlation between engine tests and bench tests was obtained. It is clear that liner surfaces with C2 (45%)(figure 4.29 and C4 (55%)(figure 4.30) are much smoother than the other liner surfaces (e.g. figure 4.31). Again the engine tests identified these as the oils likely to produce heavy polishing.
- 2) The effect of temperature upon the severity of polishing is illustrated by a comparison of figures 4.32, 4.33. Figure 4.32 although illustrating some flattening of the surface has a more clearly defined honing pattern than figure 4.33. There is

Figure 4.29 S.E.M. View of Liner with C2 at 250°C (Drip Feed)  
(200x)

on the H.F.R. liner surfaces. Figure 4.29 shows some fine scratches, although these are not as deep or continuous as those seen in the corresponding immersed test (Figure 4.8).

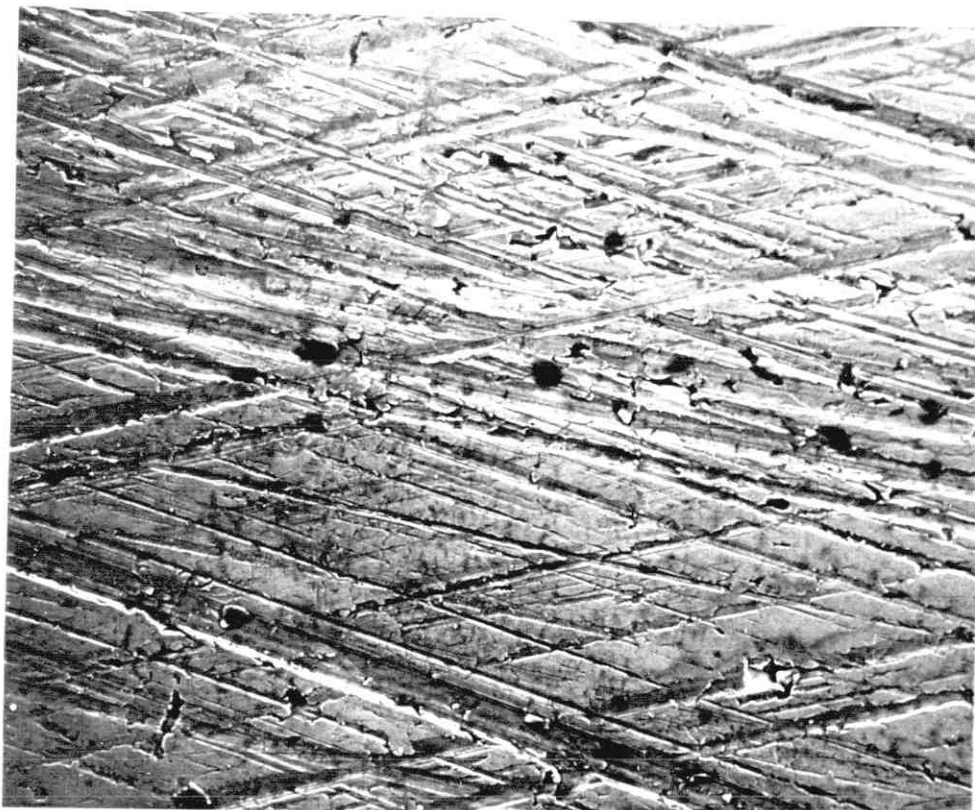
Figure 4.31 S.E.M. View of Liner with C1 at 250°C (Drip Feed)  
(200x)

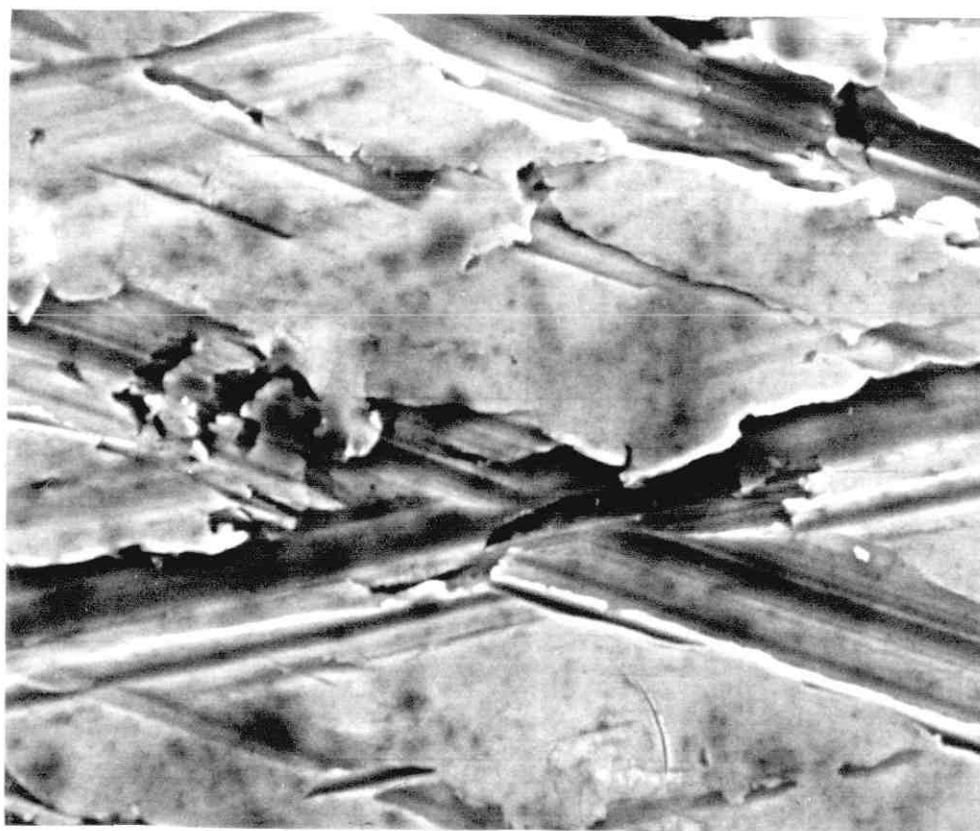
Figure 4.32 S.E.M. View of Liner with C3 at 200°C (Drip Feed)  
(1000x)

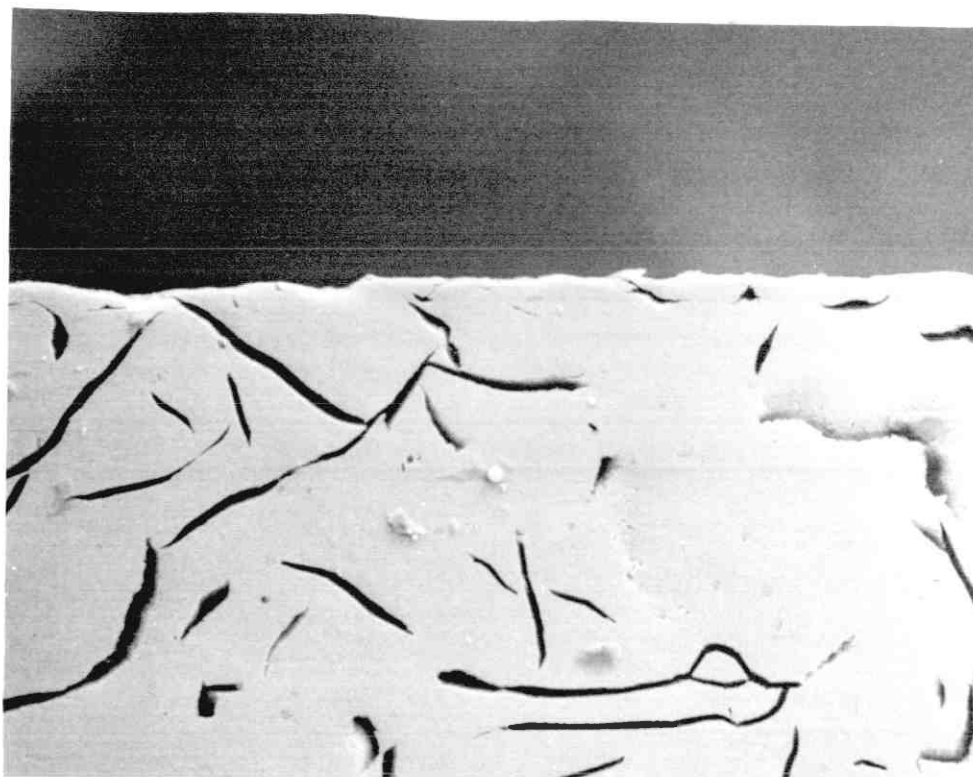
Figure 4.35 again shows that, although there is some subsurface cracking, this is not extensive for lightly polished liners. However figure 4.36 shows a semi-continuous crack formed between the tips of the graphite flakes, which is typical of that observed for all highly polished H.F.R. liners. The cracking is far more extensive for the highly polished liner, and again indicates that heavy polishing is a high stress phenomenon. There is no evidence of white layer formation, glaze formation or 'filling-in' of honing pattern as described by various authors.

Figure 4.35 Axial Micro-section of Liner with  
C6 at 250°C (Drip Feed). (200x)

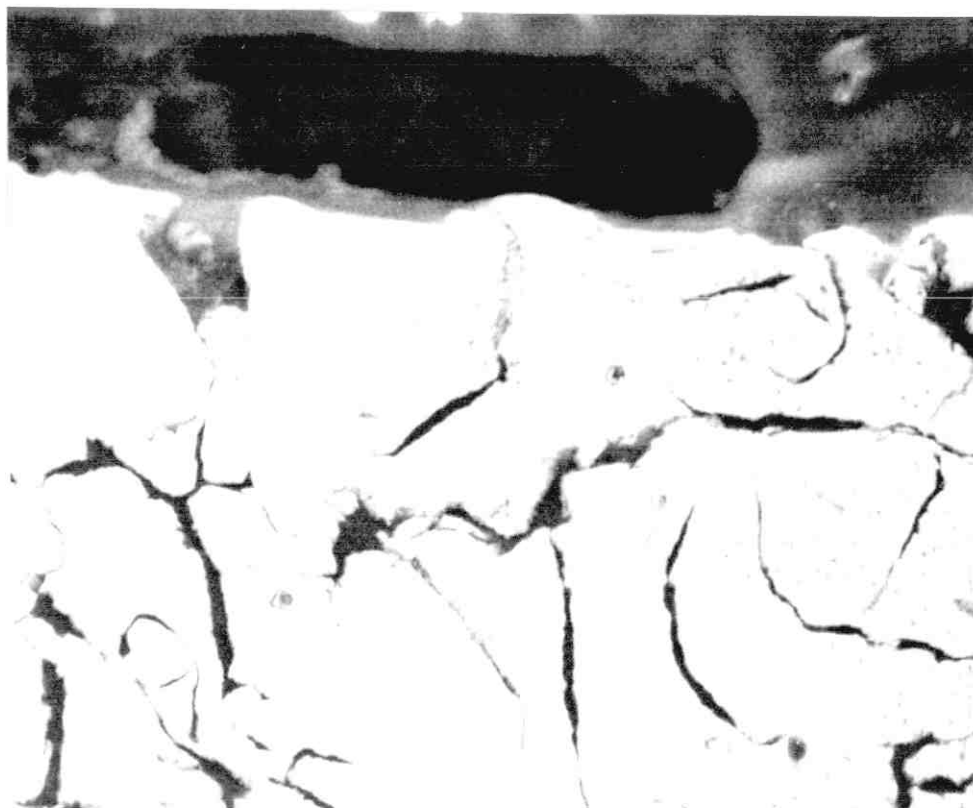
Figure 4.36 Axial Micro-section of Liner with  
C4 at 250°C (Drip Feed). (200x)

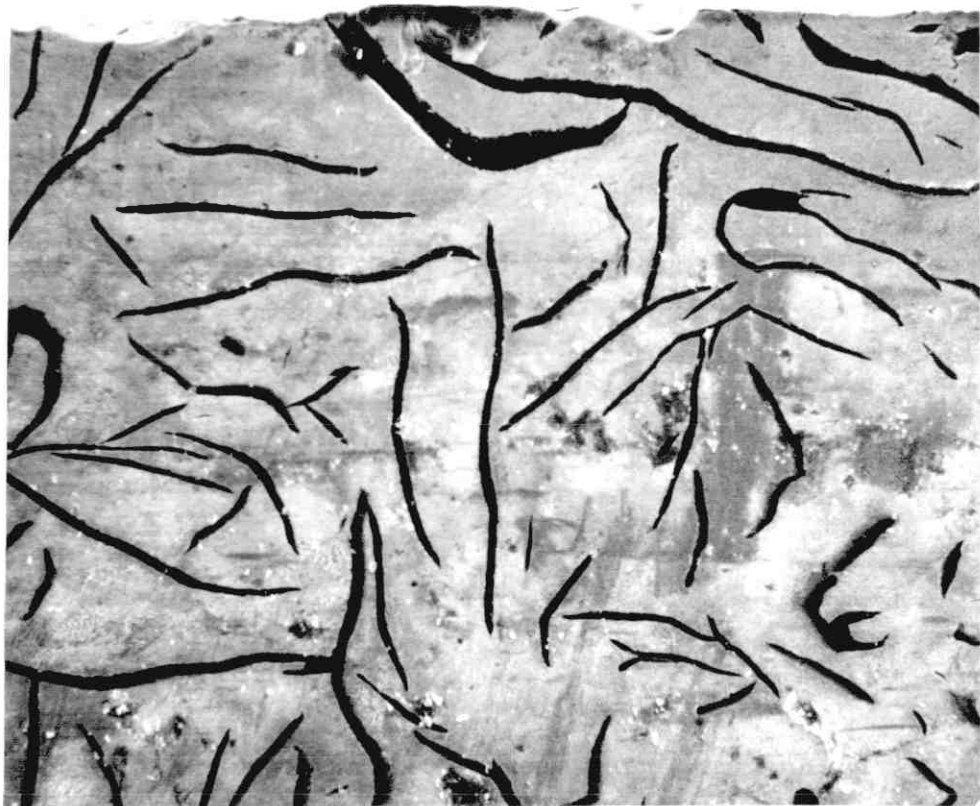
In order to compare these results with practice, two liners from a Ford Tornado engine were sectioned. Figure 4.37 shows very little evidence of subsurface cracking or deformation, and this agrees with low polishing tests seen with H.F.R. liners. Figure 4.38 shows extensive subsurface cracking to a depth greater than that seen with the H.F.R. tests. Both these photographs indicate that bore polishing is a high

Figure 4.37 Axial Micro-section of Unpolished Ford Tornado Liner. (200x)

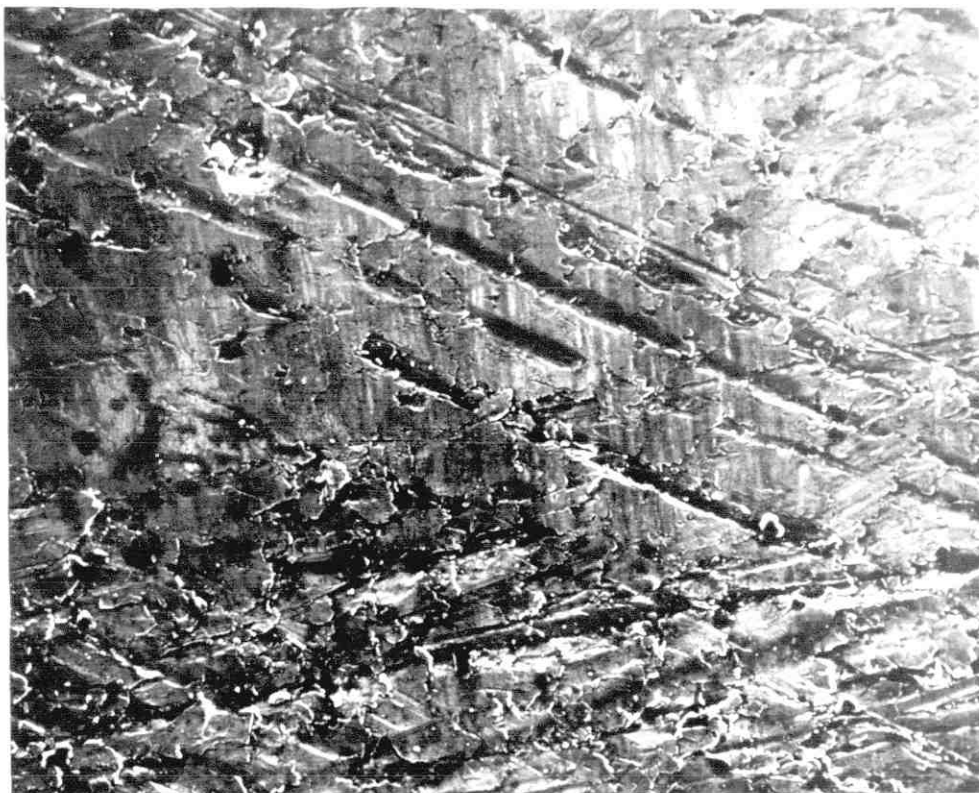
alone) gave the most smooth surfaces. This is illustrated in figures 5.8 to 5.10 .

3) Figures 5.8 and 5.11 show evidence of plastic deformation around the honing lines. As with commercial oil tests in the previous chapter it was not possible using visual S.E.M. of the liner surfaces to determine whether plastic deformation or 'filling-in' of the honing marks has occurred on heavily polished surfaces. (As in figure 5.9 ). The liners were sectioned to investigate changes in their microstructure. This is described in the next section.

Figure 5.8 S.E.M. View of Liner with B2+0.4%C<sup>(w/w)</sup> at 250°C (immersed). (200x)

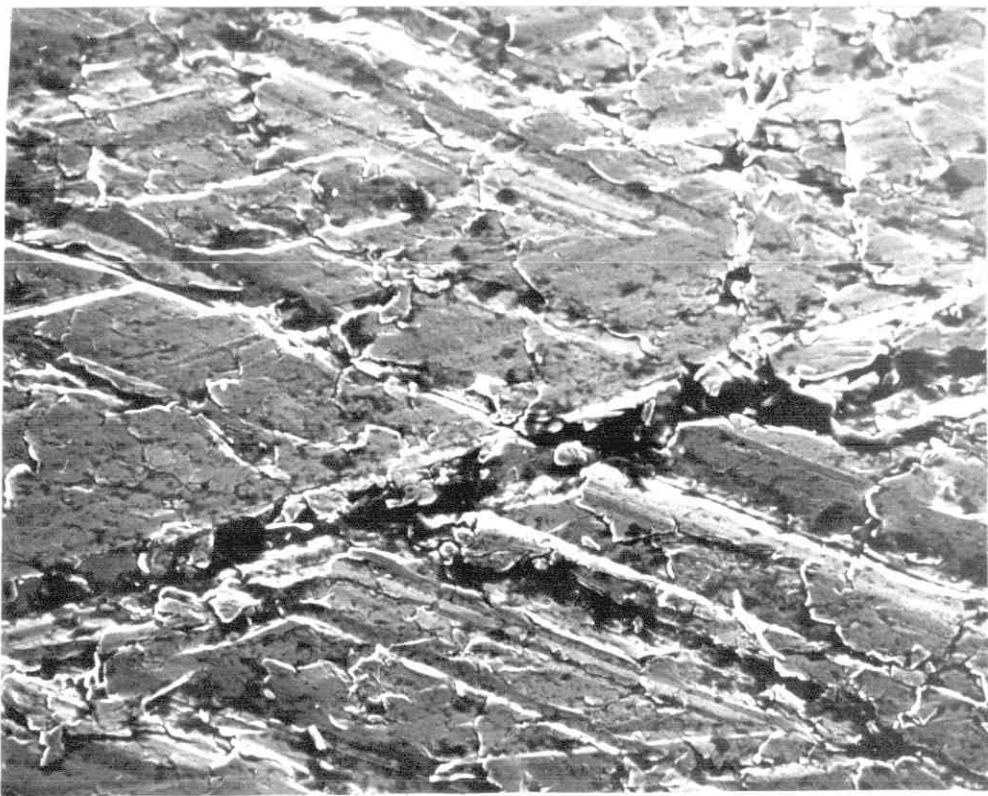
Figure 5.11 S.E.M. View of Liner with B2+0.4%C(<sup>w</sup>/w) at 200°C  
(immersed). (200x)

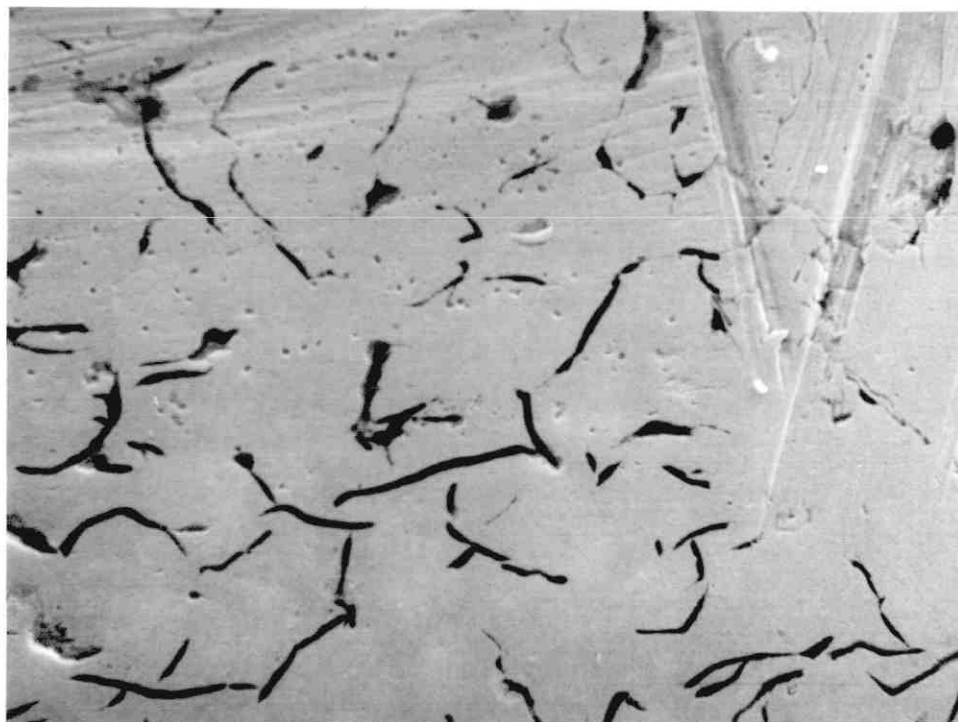
Figure 5.15 is a taper section through the boundary of wear scar (upper left-hand side) and unworn liner (upper right-hand side). There is considerably more evidence of cracking around the graphite flakes both on the surface and in the subsurface. The wear scar is also clearly pitted. The sliding direction in

Figure 5.15 Axial Taper Micro-section of Liner with  
B2+2%C (w/w) at 300°C. (200x)

these photographs is left to right.

These figures again indicate that the heavily polished surfaces (e.g. figure 5.15) are more highly stressed than the lightly polished surfaces (e.g. figure 5.14). Furthermore, there is no indication of a white layer, glaze or 'filling-in' process associated with either surface.

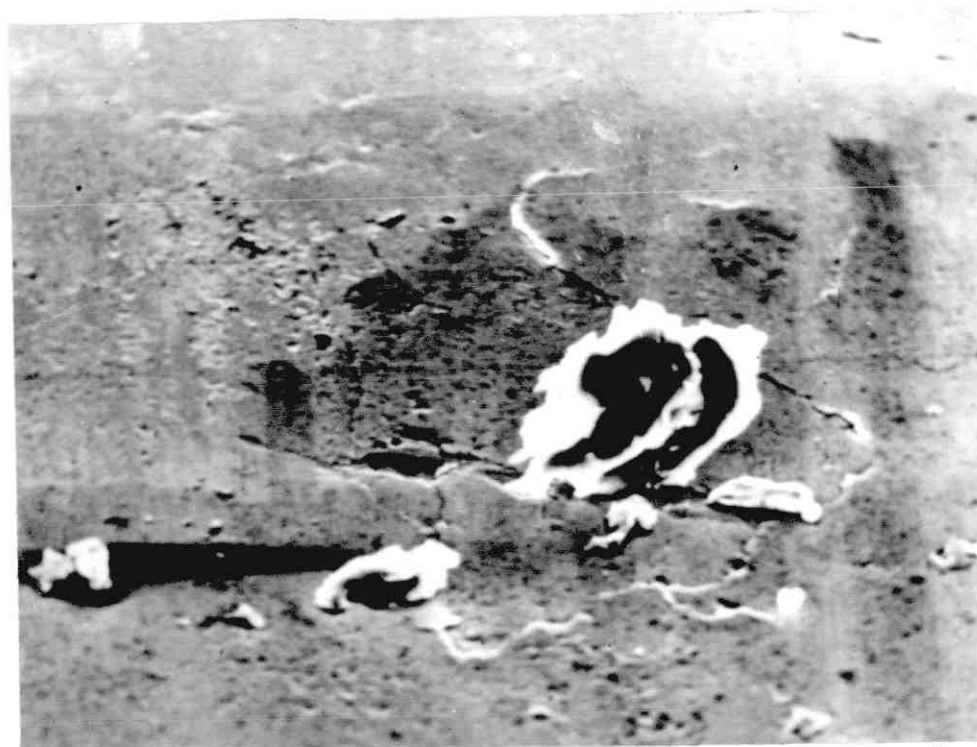
- 1) The liner lubricated with the 0.4% concentration had a well defined honing pattern whilst low and zero concentration oils (e.g. B2) and high concentration oils (e.g. 1% and 2%) had a lack of this pattern and were clearly heavily polished. This is illustrated in figures 5.26 to 5.28.
- 2) The effect of temperature was less significant than for the immersed contact tests. Figures 5.29 and 5.30 illustrate this. The amount of surface smoothening in each case is approximately the same.
3. The effect of inclining the apparatus is a reduction in the amount of surface smoothening. This is illustrated by a comparison of figures 5.8 and 5.26 . The reason for this was thought to be the generation of thicker and more stable boundary films.

Figure 5.27 S.E.M. View of Liner with  $B_2$  at  $250^{\circ}C$   
(Drip Feed). (200x)

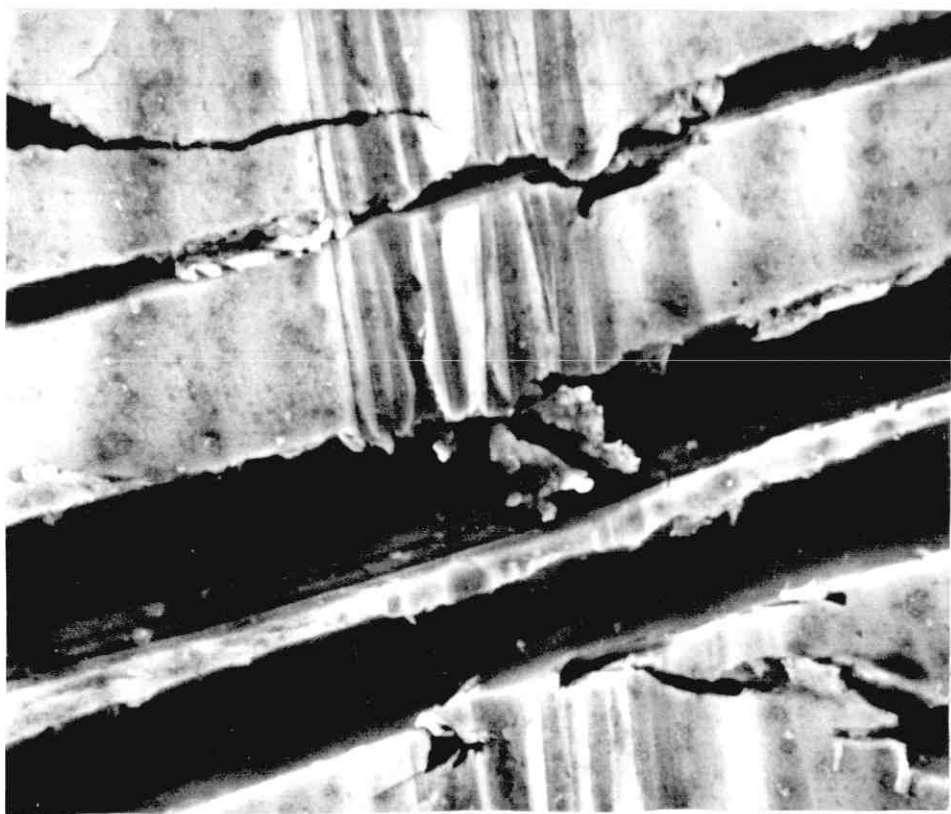
Figure 5.29 S.E.M. View of Liner with B2+0.5%C<sup>(w/w)</sup> at 250°C  
(Drip Feed). (1000x)
